CNOOC UGANDA LIMITED

# KINGFISHER OIL PROJECT, HOIMA DISTRICT, UGANDA - GROUNDWATER SPECIALIST STUDY

REPORT - VOLUME 4, STUDY 3

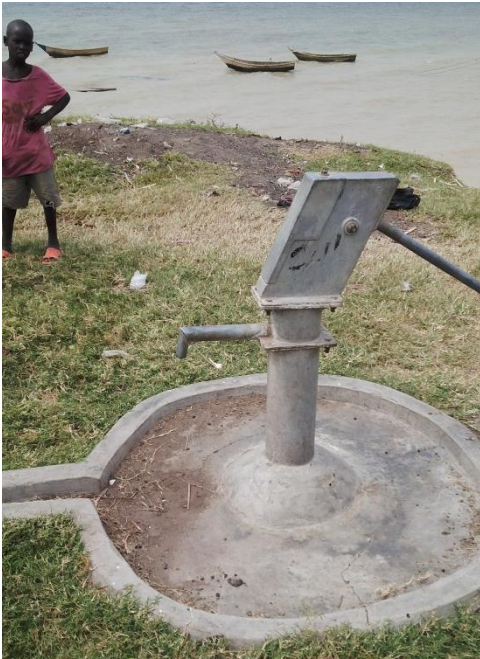
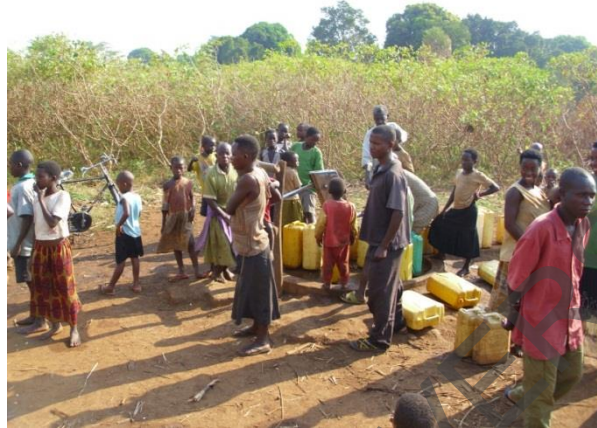
Figure 9: Typical well installation in the Kingfisher project area

As discussed earlier, measuring water levels in the wells was difficult due to the type of pump installations typical for the area, Figure 9.

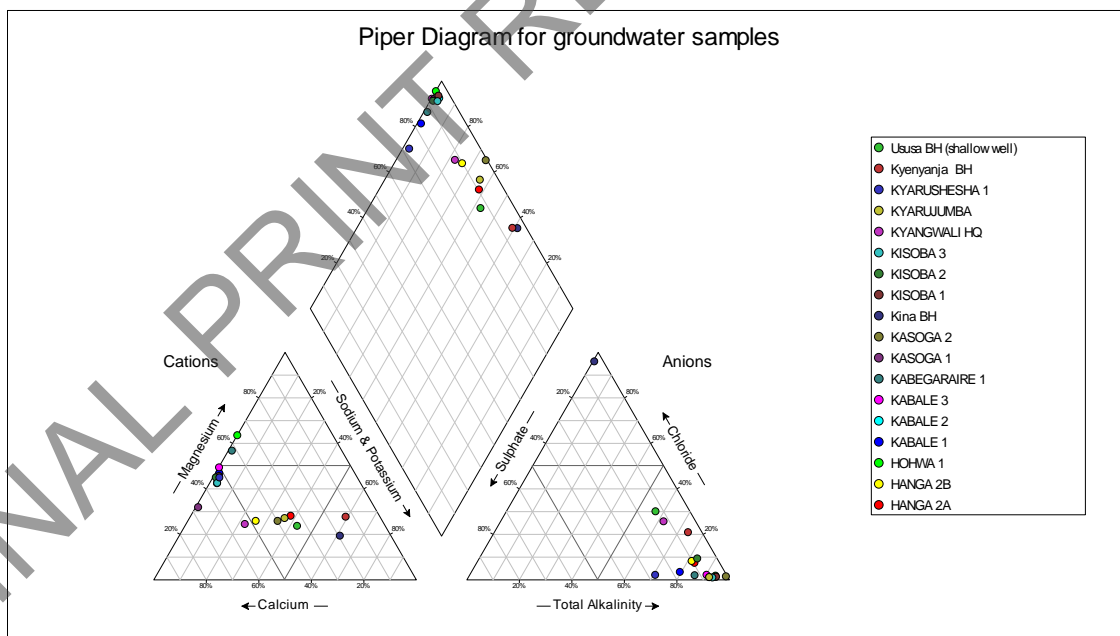
Figure 10: Piper diagram for the groundwater samples

From the plotted Piper Diagram, it can be seen that most of the escarpment boreholes can be characterised as Ca/Mg bicarbonate type water, which is expected from the type of geology and recharge mechanisms (rapid recharge after rainfall events) occurring on the escarpment.

The groundwater character of the lake front boreholes is less distinct, and most can be classified as Na Mg – bicarbonate with enrichment of Cl that contribute to the elevated salinity. The source of the Cl in groundwater cannot be directly linked to the lake water since the lake water samples (Kina shores, Lake Albert, Nsonga shorelines) all had very low Cl values (0.03 mg/L). The build-up of salts on the lake front plains is the result of evapotranspiration and a seasonal water level fluctuation. It is assumed that the gradient of groundwater flow towards the lake on the flats is very low and this will also contribute to the salinization of the upper soil profiles.

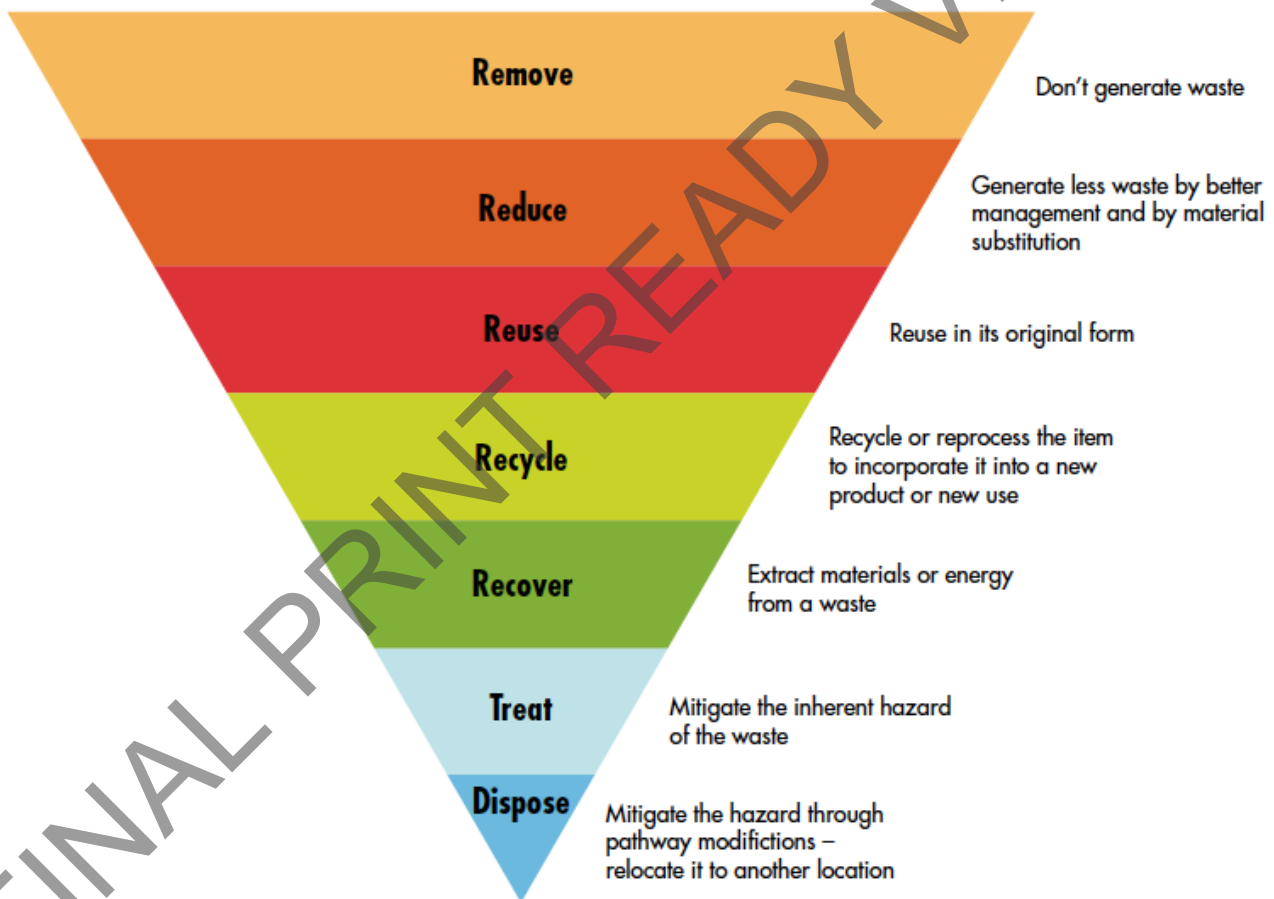
Figure 12: The solid waste management hierarchy

CNOOC’s Waste Management Design Philosophy (2016) commits the company to comply with the key principles underpinning the waste hierarchy, which are, wherever possible, to avoid or reduce the generation of waste (or waste toxicity) at source, and/or to re-use or recycle the waste, before considering disposal options. This philosophy is also enshrined in the Ugandan Waste Management Regulations and in most international waste management standards and guidelines, including those of the IFC/World Bank.

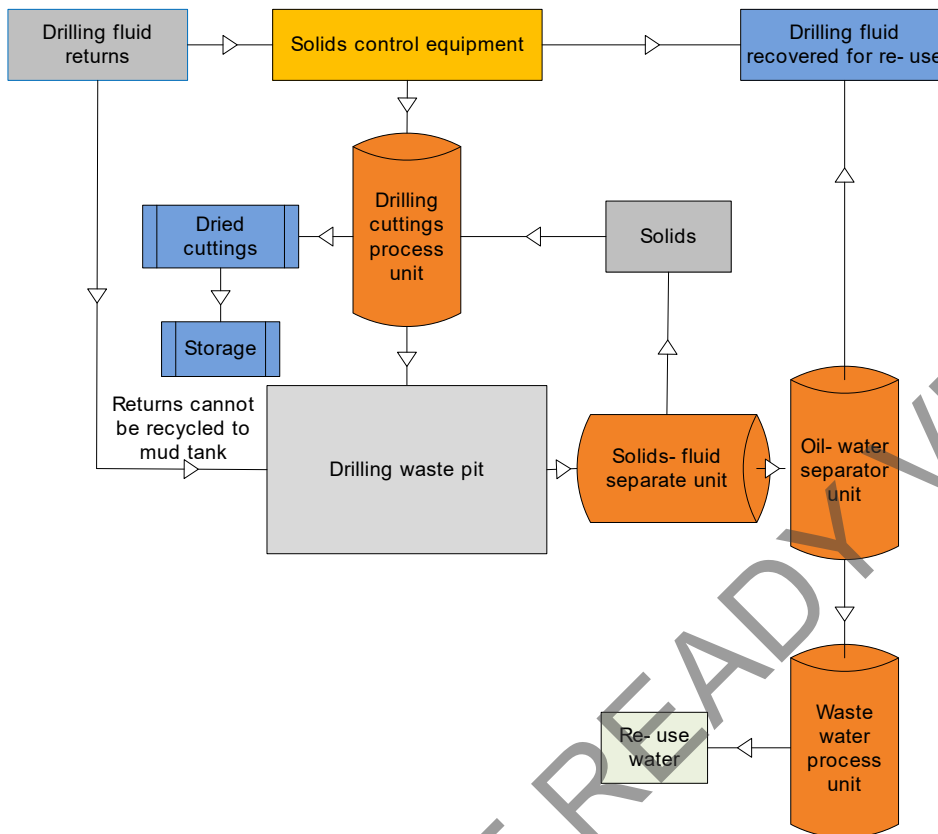
Figure 13: Drilling waste process and recycle flow chart.

solid-liquid separation and water-oil separation, solid, water process. Typical drilling waste process and recycle flow chart is shown in Figure 13.

On the rig site drilling fluid that returns from the drill hole will be transferred to solid control equipment for primary processing. The fluid will be recovered for re-use and the cuttings will be transferred to the drilling cuttings process unit for secondary processing. The majority of drill cuttings will be processed to dried cuttings with oil content below 5%. These cuttings will be stored in specific containers. The remaining fluid and tiny solid particles will be discharged to the drilling waste pit. Returned drilling fluid that cannot be recycled to the mud tank (such as waste fluid after cementing) will be discharged to the drilling waste pit. These wastes will be pumped to the solids-fluid separate unit for separating. Solids will be transferred to the drilling cuttings process unit for further processing and the fluid will be transferred to the oil-water separator (to recover oil for re-use), and the waste water processing unit (to recover water for re-use).
